**RE: Jim Beam Old Crow Warehouse Facility, Glenn's Creek  
USACE # LRL-2007-01461-pjl  
KDOW # AI 40205**

**AFTER-THE-FACT APPLICATION  
FOR  
DEPARTMENT OF THE ARMY PERMIT  
&  
WATER QUALITY CERTIFICATION**

**UNAUTHORIZED STREAM ACTIVITIES PERFORMED  
AT THE  
JIM BEAM OLD CROW WAREHOUSE FACILITY  
WOODFORD COUNTY, KY**

**KDOW AI NO. 40205  
USACE PROJECT # LRL-2007-01461-PJL**

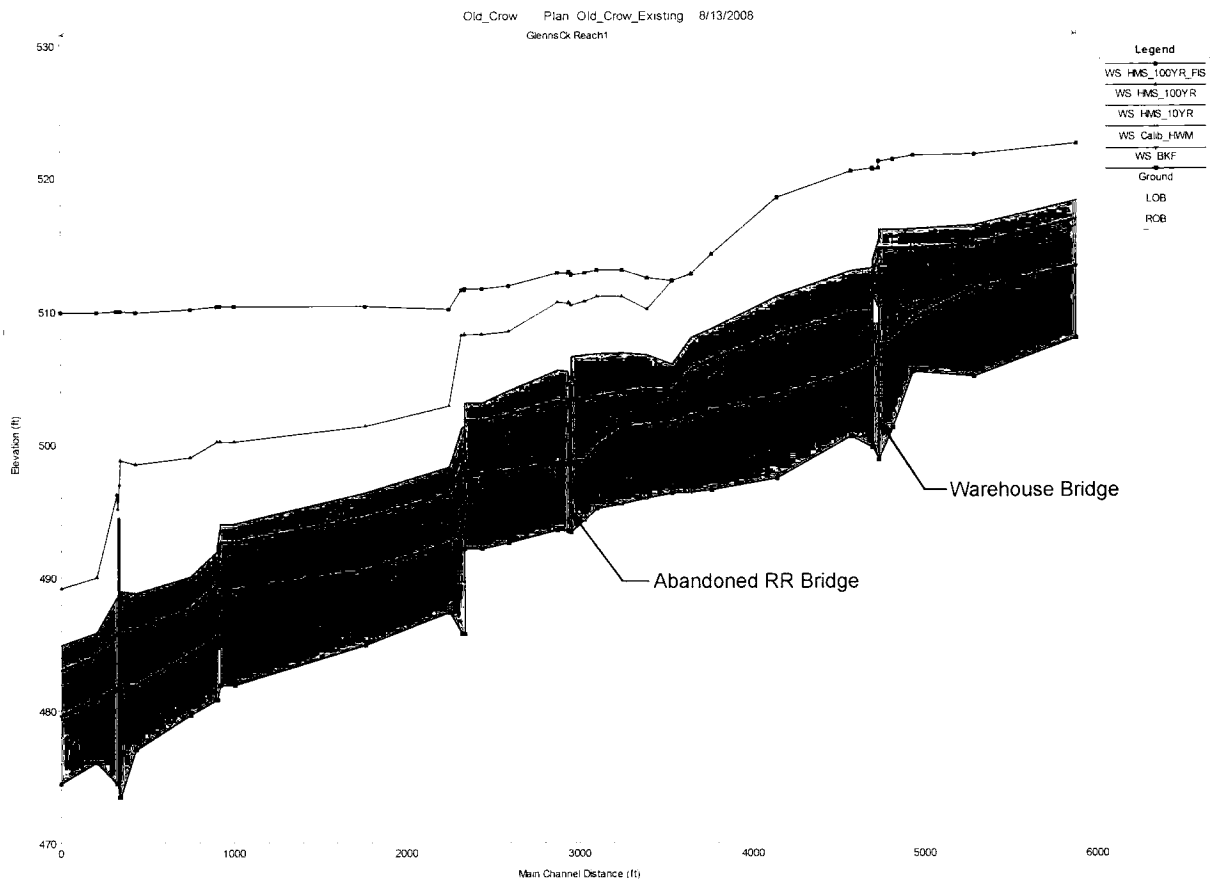
**Figure 2.7:** HEC-RAS Water Surface Profiles for Glenns Creek for existing conditions.

Profiles incorporated into the model include the bankfull discharge estimate (1,600 cfs), the discharge from the April storm event (5,000 cfs), and the 10- and 100-year storm events predicted from the HEC-HMS model. The 100-year storm event was modeled with both a normal depth boundary condition and the 100-year Kentucky River boundary condition. Figure 2.7 shows these five water surface profiles for the study reach for existing conditions.

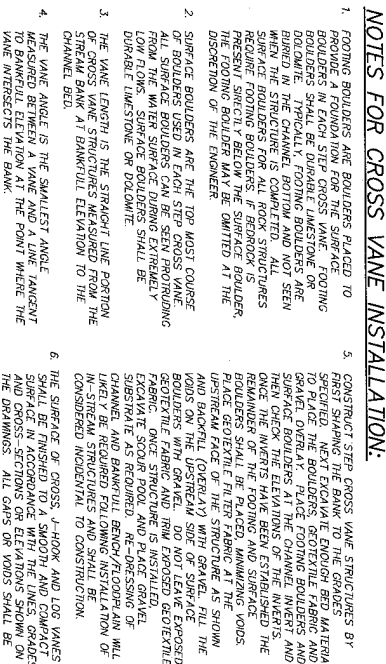
DETAIL - CROSS VANE WITH STEP

1. FOOTING BOULDERS ARE BOULDERS PLACED TO PROVIDE A FOUNDATION FOR THE SURFACE BOULDERS IN EACH STEP CROSS VANE. FOOTING BOULDERS ARE PLACED IN THE CHANNEL BOWLS, TYPICALLY, FEET BOULDERS ARE BUILT IN THE CHANNEL BOTTOM AND NOT SEEN WHEN THE STRUCTURE IS COMPLETED. ALL VANS MUST HAVE FOOTING BOULDERS IF BEDROCK IS PRESENT DIRECTLY BELOW THE SURFACE BOLDER, THE FOOTING BOLDER MAY BE OMITTED AT THE DISCRETION OF THE ENGINEER.

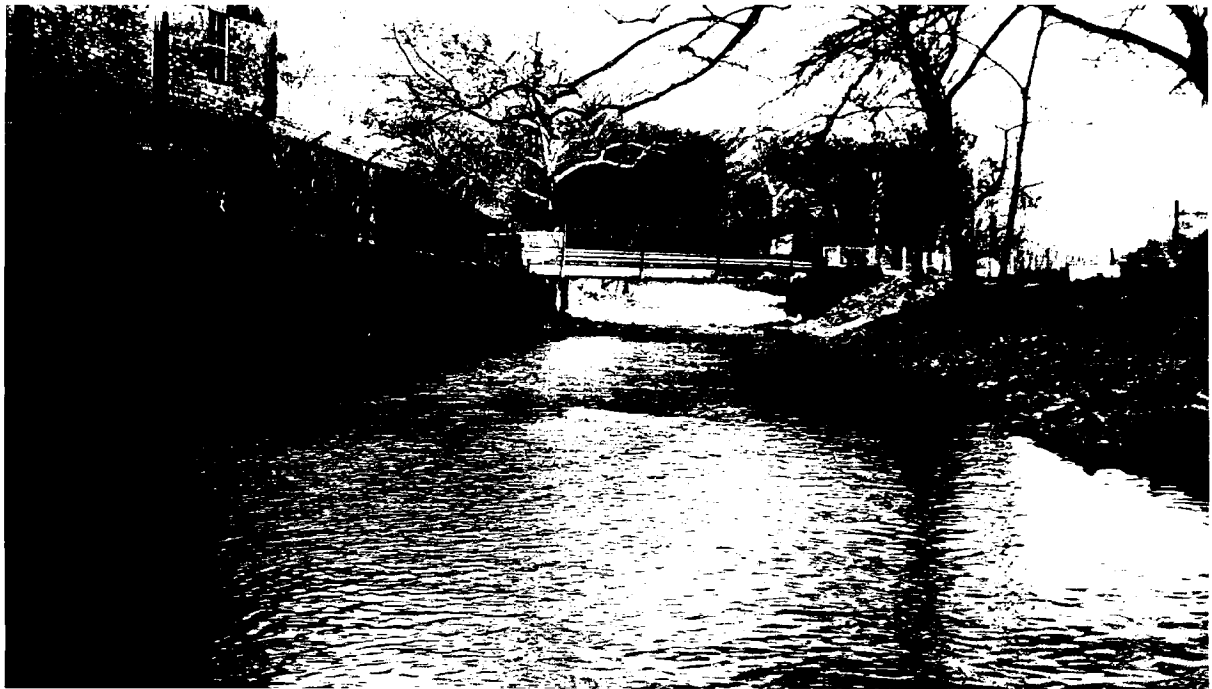
Photo 6. Reach B looking upstream at the run cross section. Note retaining wall along the right streambank.

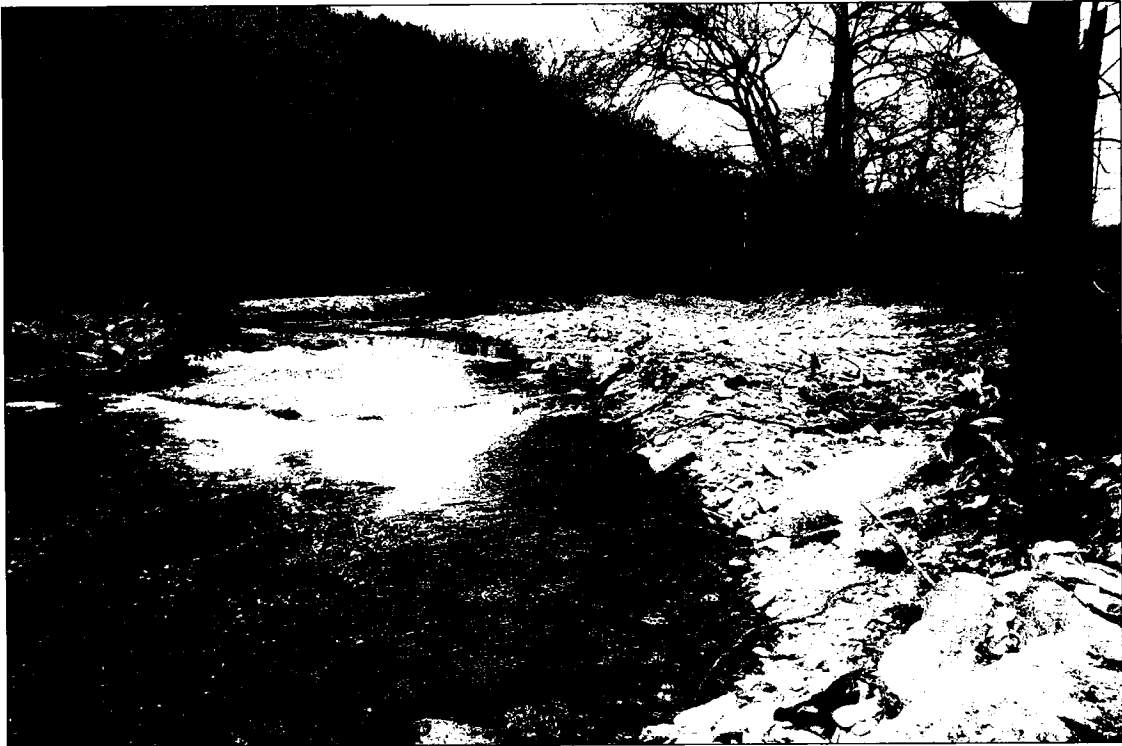
Glenn's Creek impact reach at the Old Crow low-water crossing (4/14/08)

Stream bed substrate and debris were mechanically removed to the underlying bedrock within the ordinary high water limits of the channel. Material was pushed against both banks and also stockpiled within the floodplain. Approximately 1,200 linear feet of stream bed was affected, resulting in the displacement of over 2,500 cu yds of material. Within the vicinity of an existing access bridge, bedrock was further broken and removed to increase the flow capacity under the bridge.

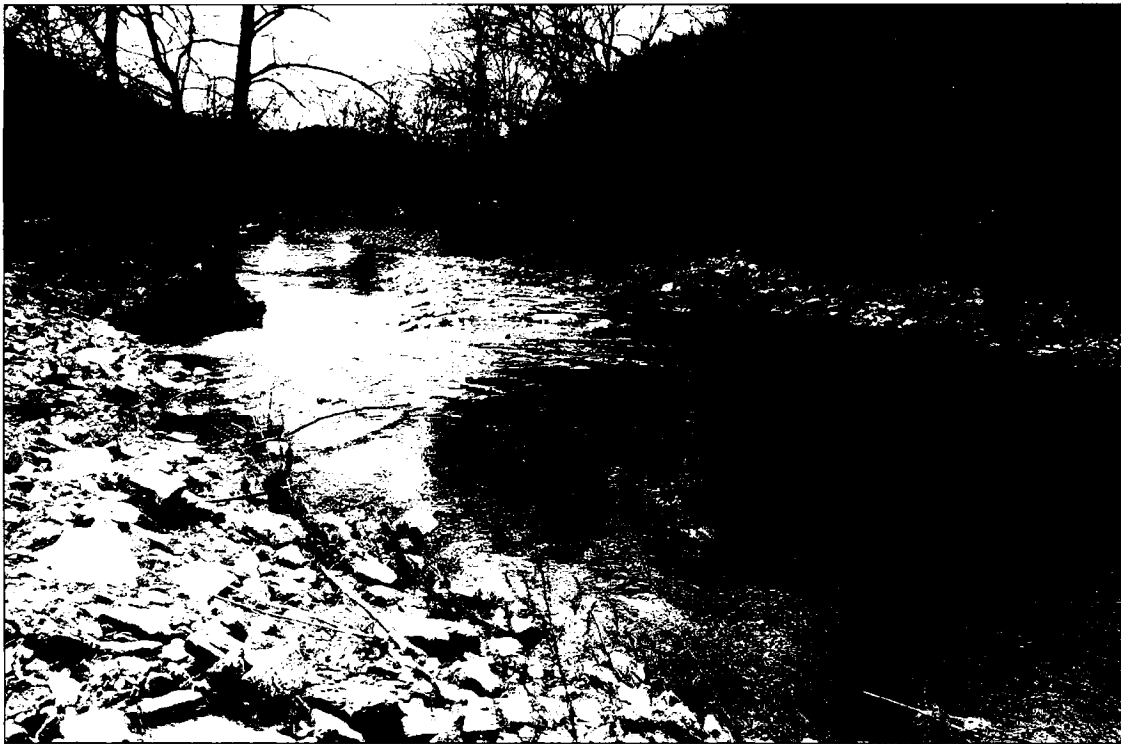
Glenn's Creek cross-channel sediment bar (4/14/08)
